UPPER TURTLE LAKE, BARRON COUNTY

2023-2027 Aquatic Plant Management Plan
WDNR WBIC: 2079800

Prepared by: Dave Blumer, Lake Educator
February, 2023

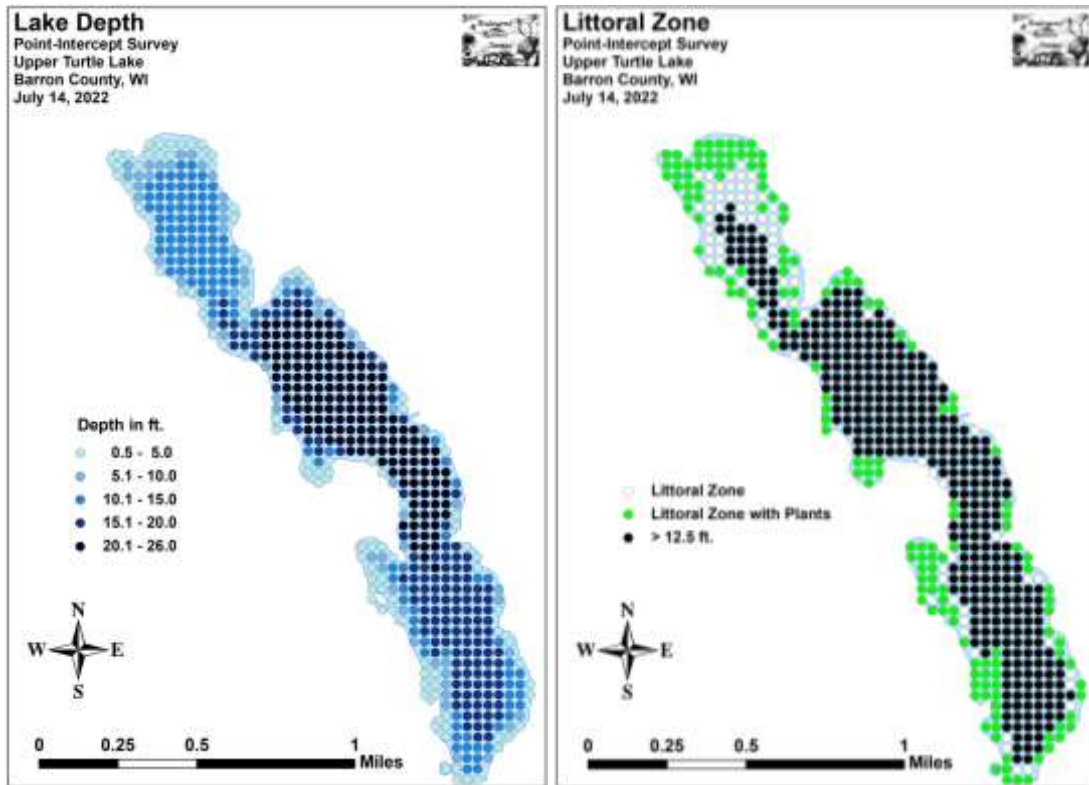
Upper Turtle Lake is a drainage lake in west-central Barron County, Wisconsin about 2.5 miles east of the Village of Turtle Lake. The lake covers 427 acres, has a maximum depth of 26 feet and an average depth of 14-ft, and 7.37 miles of shoreline. The north basin is relatively shallow while the south and central basins are a fair bit deeper. Because of this, most of the north basin is part of the littoral zone (area of a lake that supports aquatic plant growth). More of the littoral zone exists in a narrow band around the rest of the lake (Figure 4).

Figure 4: 2022 Depth and Littoral Zone of Upper Turtle Lake

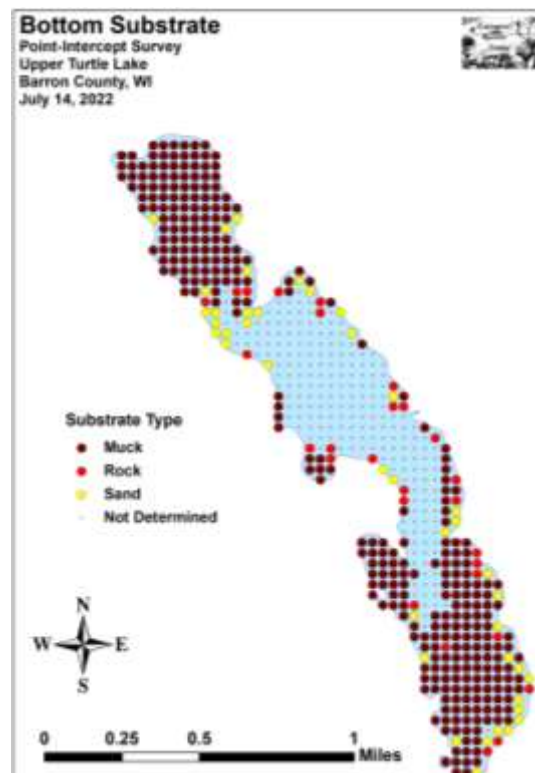
The majority of the lake bottom consists of muck with some rock and sand interspersed throughout (Figure 5).

Figure 5: Lake Substrate in 2022

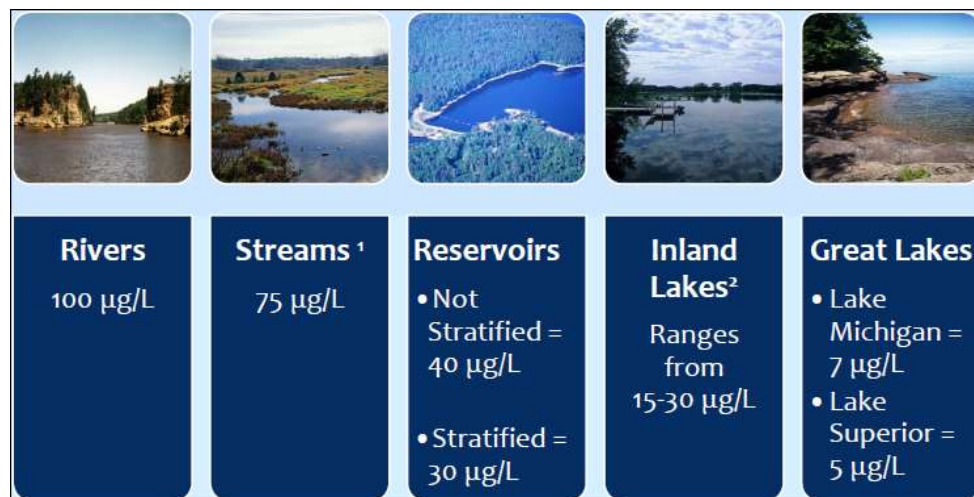
Figure 6: Wisconsin numeric water quality standards for phosphorus (WDNR, 2018)

The Wisconsin acceptable standard for summer TP in the REC category for natural inland lakes like UTL is a mean concentration $\leq 30 \mu\text{g}/\text{L}$ (Figure 6). The WisCALM assessment protocol for Chla is based on the number of days in a sampling season (July 15-September 15) that have moderate algal levels based on Chla concentrations that exceeds $20 \mu\text{g}/\text{L}$. Once that level has been exceeded, the amount of algae in the surface water it represents discourages people from swimming (Figure 7). If the concentration of Chla exceeds $20 \mu\text{g}/\text{L}$ for more than 5% of the expected lake use days, then the water is considered impaired.

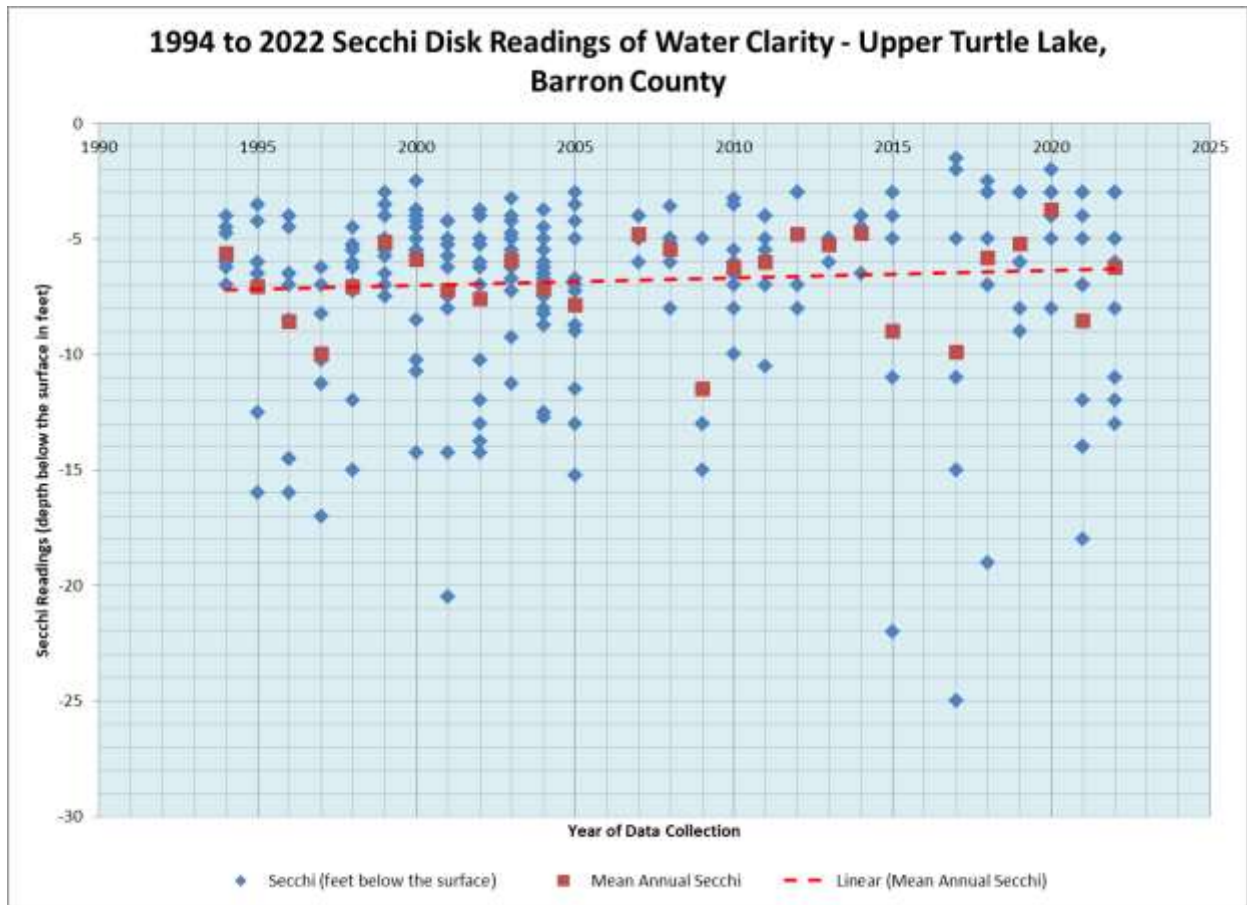
Figure 8: 1994 – 2022 Secchi depth readings, average annual readings, and trend line

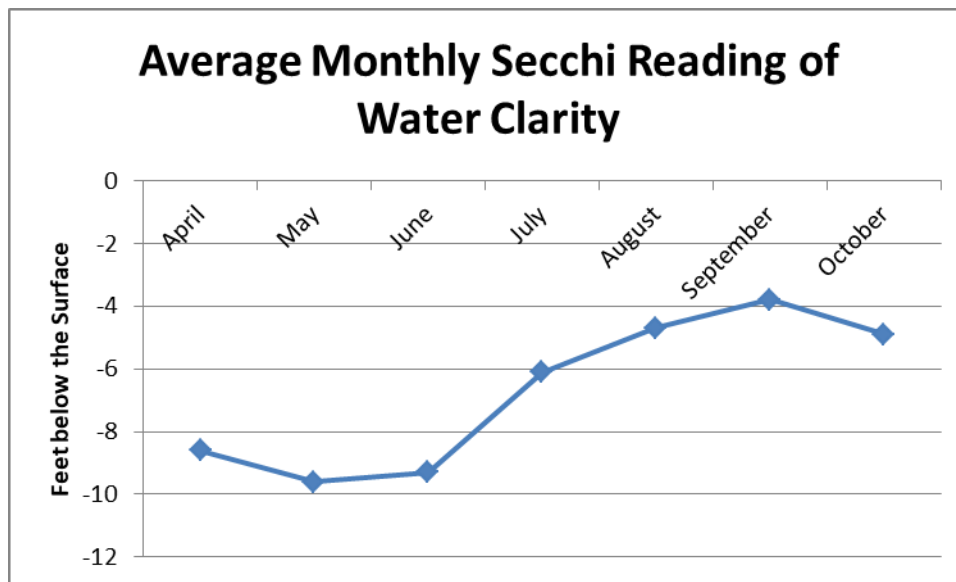
This pattern is primarily driven by water temperature – with cooler water unable to support abundant algae and aquatic plant growth (except for CLP) through June. Also through June, dense or abundant CLP (Figure 10) growth can interfere with the growth of native aquatic plants. In July, two things happen – the water continues to warm, and CLP dies and senesces releasing phosphorus into the water. The warmer water and increase in phosphorus leads to the rapid growth of algae in August and September reducing aquatic vegetation to floating leaf plants - like lily pads (Figure 11). Plants like coontail, duckweed, and watermeal (Figure 11) that are not rooted to the bottom of the lake and can pull their needed nutrients from the lake water also do well.

Figure 9: Average monthly Secchi depth readings of water clarity (based on all 1994-2022 CLMN data)

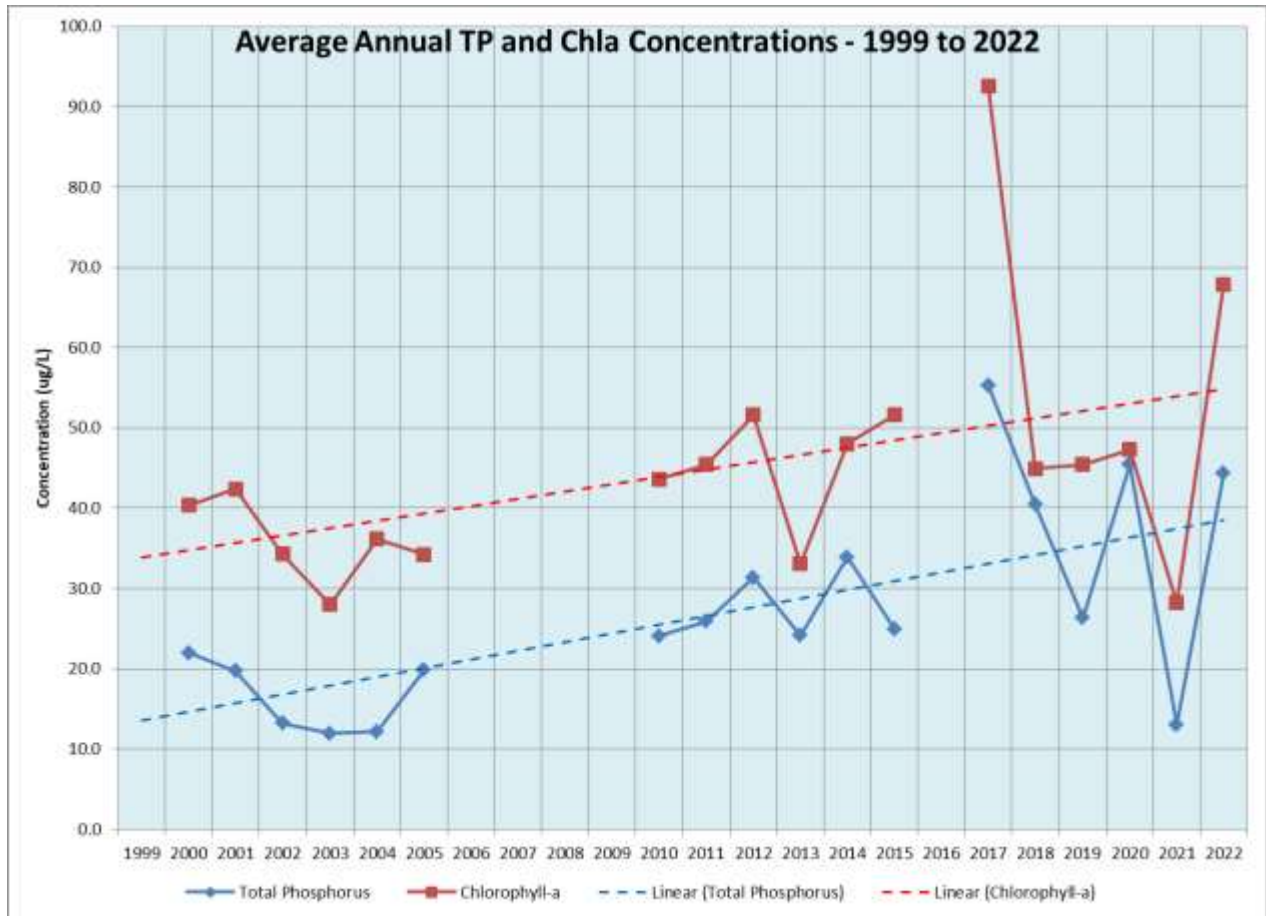
The water chemistry data shows the most noticeable decline in water quality. Since 1999, there has been a steady increase in both TP and Chla concentration in the lake. There are blocks of data from 2000 to 2005, from 2010 to 2015, and from 2017-2022 (Figure 12). There is a definite increase from the early 2000's to the early 2010's, and another definite increase from the early 2010's to the late 2010's and early 2020's. 2017 was the worst year on record for water quality with large spikes in both TP and Chla. 2017 was also the year when 130+ acres of CLP were mapped in the lake and no management was completed.

Figure 12: Average annual TP and Chla concentrations plus trend lines

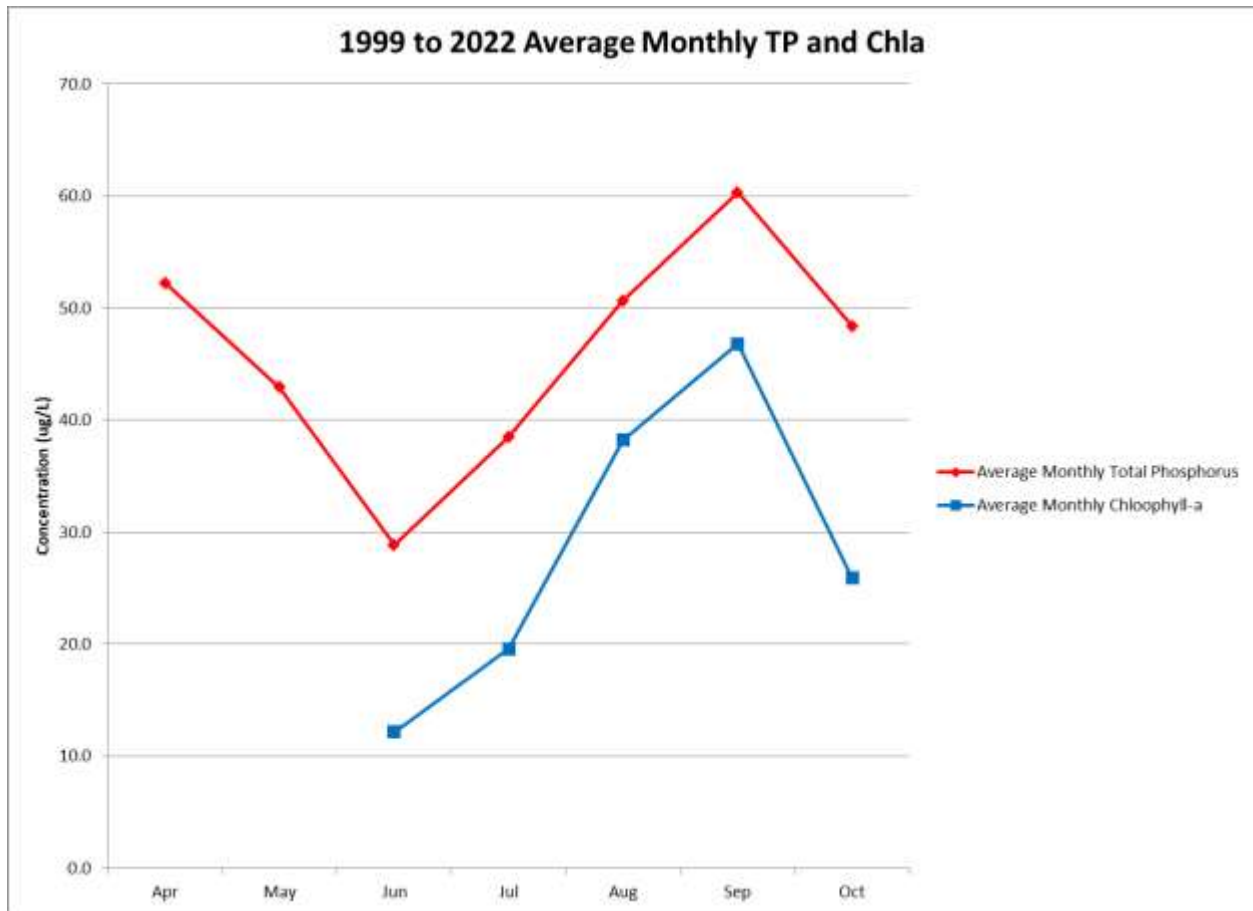
Monthly concentrations of TP and Chla follow a similar pattern to that of the Secchi disk readings of water clarity. Concentrations start off low in the spring and early summer, and then increase sharply in July, reaching their peak in September. As the water cools down in October the concentrations go down again (Figure 13).

Figure 13: Average monthly TP and Chla concentrations (based on all 1999-2022 CLMN data)

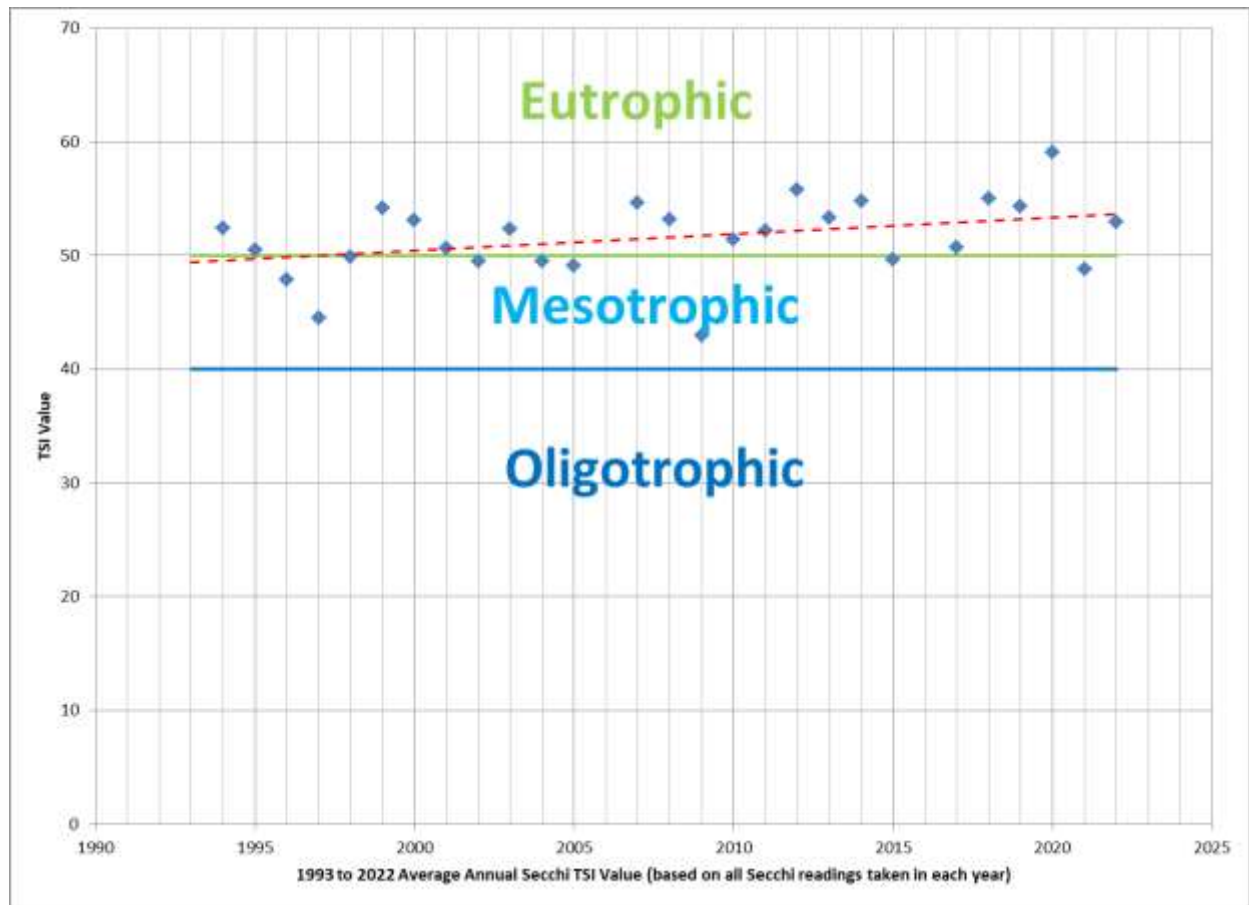
Like the actual values recorded during sampling, TSI values can be used to create figures that show increasing or decreasing values. In Figure 17, the average annual Secchi TSI value for each year of data has been posted. The declining Secchi disk reading and where it fits in the 0-100 scale (oligotrophic, mesotrophic, or eutrophic) is easy to see.

Figure 17: Average Annual Secchi TSI value

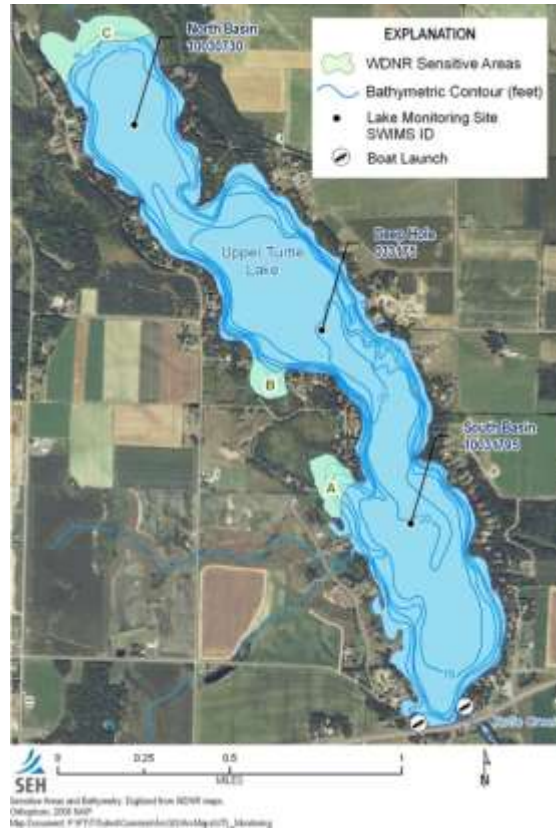
Every body of water has areas of aquatic vegetation that offers critical or unique fish and wildlife habitat. Such areas can be identified by the WDNR and identified as Sensitive Areas per Ch. NR 107. Figure 19 shows the sensitive areas identified by the WDNR (2001) in UTL. Aquatic habitat areas provide the basic needs (e.g. habitat, food, nesting areas) for waterfowl, fish, and wildlife. Disturbance to these areas during mechanical harvesting should be avoided or minimized and chemical treatment is generally not allowed. Areas of rock and cobble substrate with little or no fine sediment are considered high quality walleye spawning habitat. No dredging, structures, or deposits should occur in these sensitive areas. Further details for each sensitive area can be found in the Upper Turtle Lake Sensitive Area Designation (WDNR, 2001).

Figure 19: Sensitive Areas and Water Quality Sampling Sites in Upper Turtle Lake (SEH, 2011)

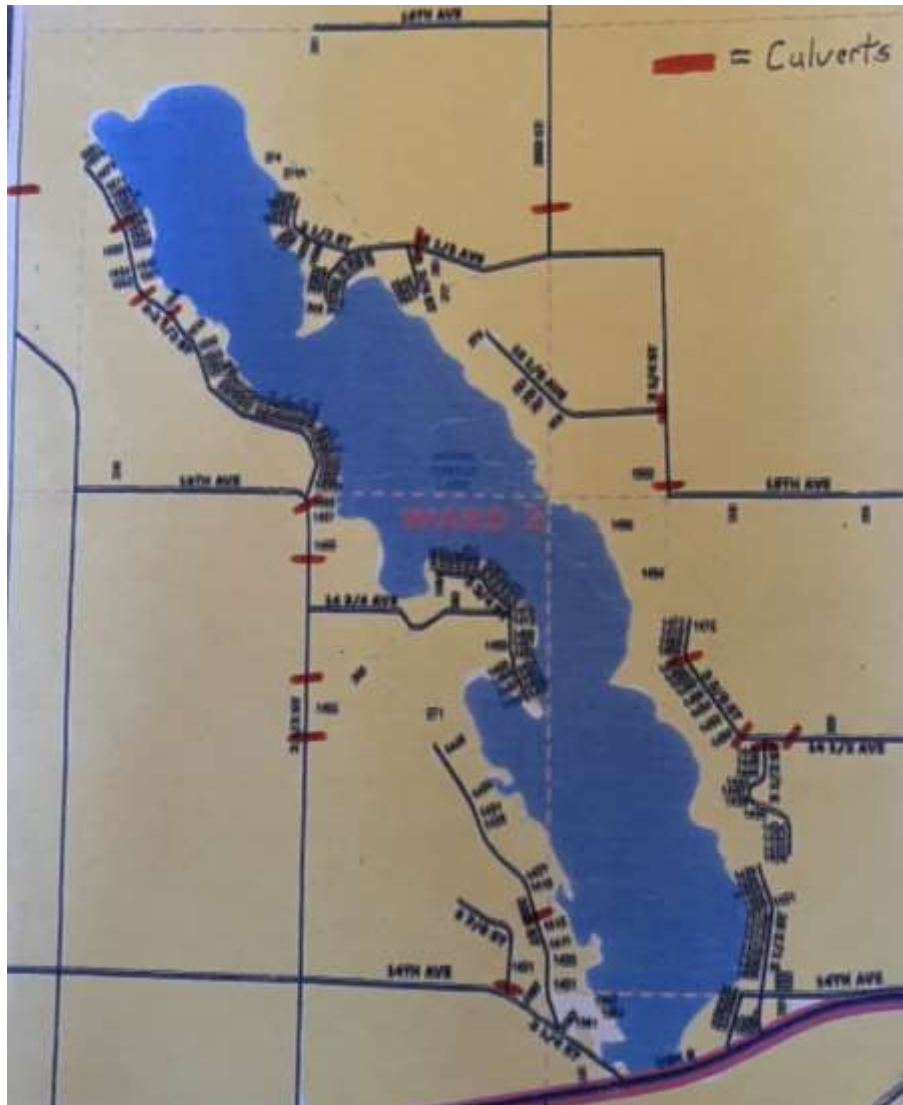
Even if a waterway is considered intermittent – only flows during spring snowmelt or during large rain events – the sediment and other pollutants carried down them to the lake can cause problems. A culvert survey can be done within a small watershed like the one that surrounds UTL to identify those culverts that are not functioning properly. Additional survey work can be done to evaluate the waterway to determine if they can be improved in some way. A preliminary map has already been created that shows the location of the culverts closest to the lake (Figure 22). To complete the inventory, each culvert needs to be evaluated on various parameters as mentioned in several monitoring guidelines. In addition, some level of watershed monitoring could be completed to estimate nutrient and sediment load to the lake and how certain BMPs could reduce that load.

Figure 22: Location of culverts under roads around Upper Turtle Lake (map provided by UTLD Volunteers from the fall of 2022)

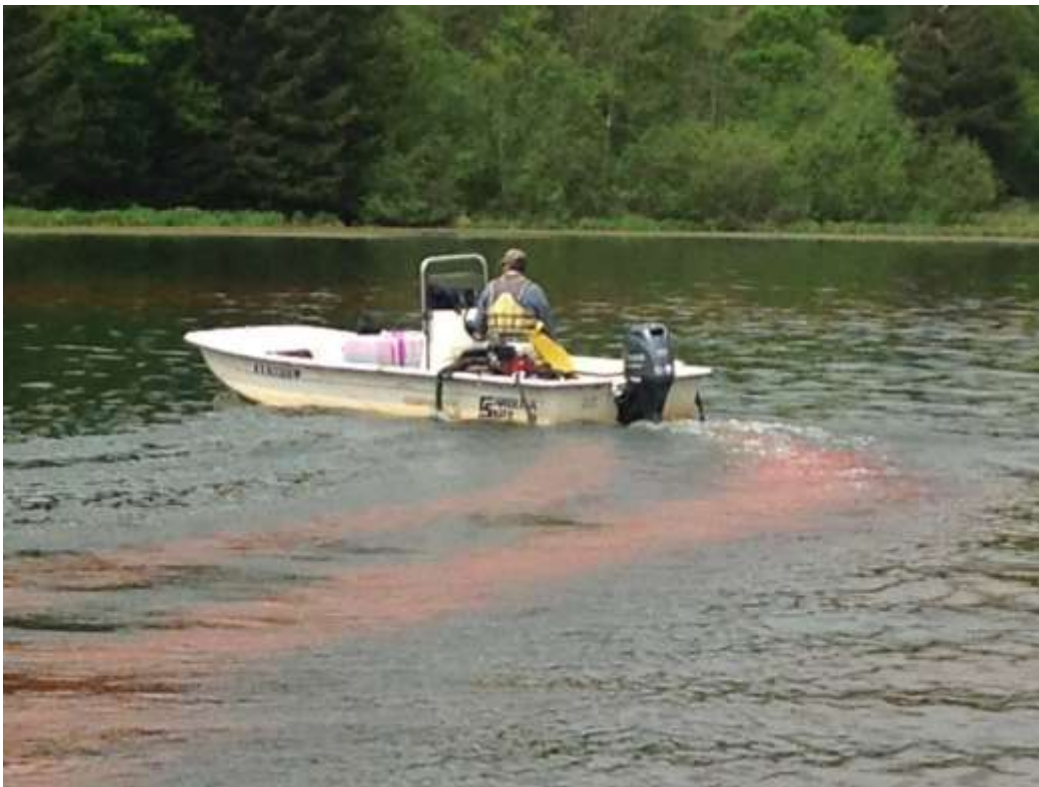
Figure 24: Dale Dressel with Northern Aquatic Services applying Rhodamine dye to Upper Turtle Lake on May 22, 2018

On May 22, 2018 nearly 100-lbs of liquid Rhodamine dye was applied by Northern Aquatic Services (Figure 24) to 72 acres of water in the north basin of UTL. The concentration of the dye, once spread through the entire north basin, was expected to be 10 ppb. The conditions the dye was applied under were perfect with water temperature at about 60°F, air temperature at about 73°F and no wind. Weather conditions remained “perfect” for several days after the application.

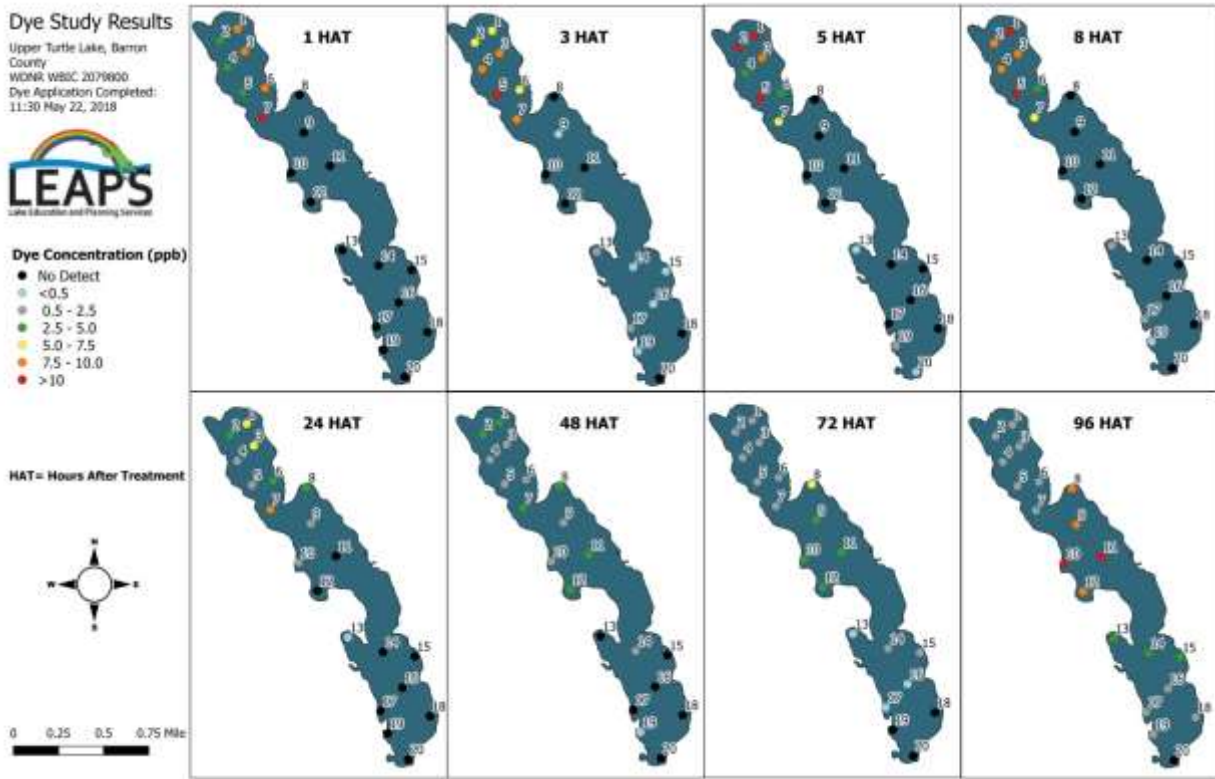
The dye applied to the water acted like it was expected except that it took a lot longer than anticipated for it to leave the north basin and begin spreading throughout the lake. When the dye was finally picked up outside of the north basin at 24 hours after treatment, it was in relatively low concentrations. The highest concentrations reached within the treated area were between five and eight hours after treatment, with a few of these exceeding what would have been 10 ppb (Figure 25). It took until 48 hours after treatment for the dye to leave the north basin where it was applied. When it did leave, the concentration was not very high with the exception of a couple locations in the center of the middle bay (Figure 25). At no time during the 96 hour sampling plan did the dye reach the outlet of the lake.

Figure 25: Rhodamine dye movement in Upper Turtle Lake (LEAPS, 2018)

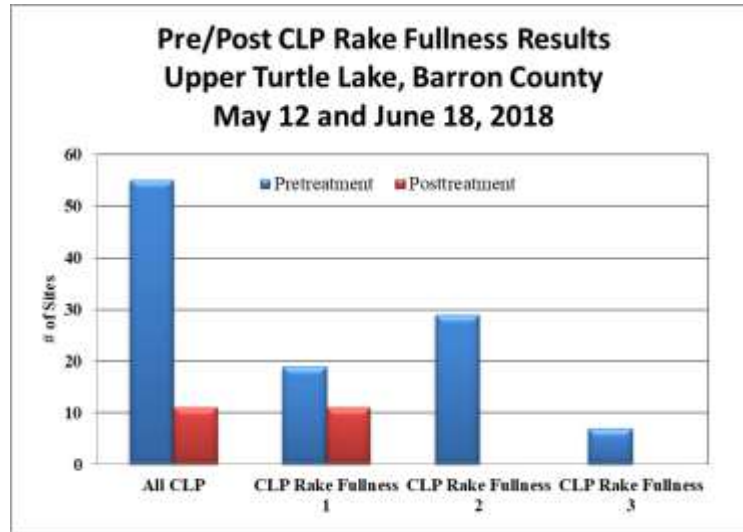
Figure 29: Changes in CLP Rake Fullness

found at 55 of 66 sites (Figure 28). During the post-treatment survey, CLP was found at only 11 points (Figure 28). Each of these detections was a plant that was only a couple of inches tall making it likely they it sprouted after the chemical treatment. These results demonstrated a highly significant decline in total CLP as well as rake fullness 2; and a moderately significant decline in rake fullness 3 (Figure 29).

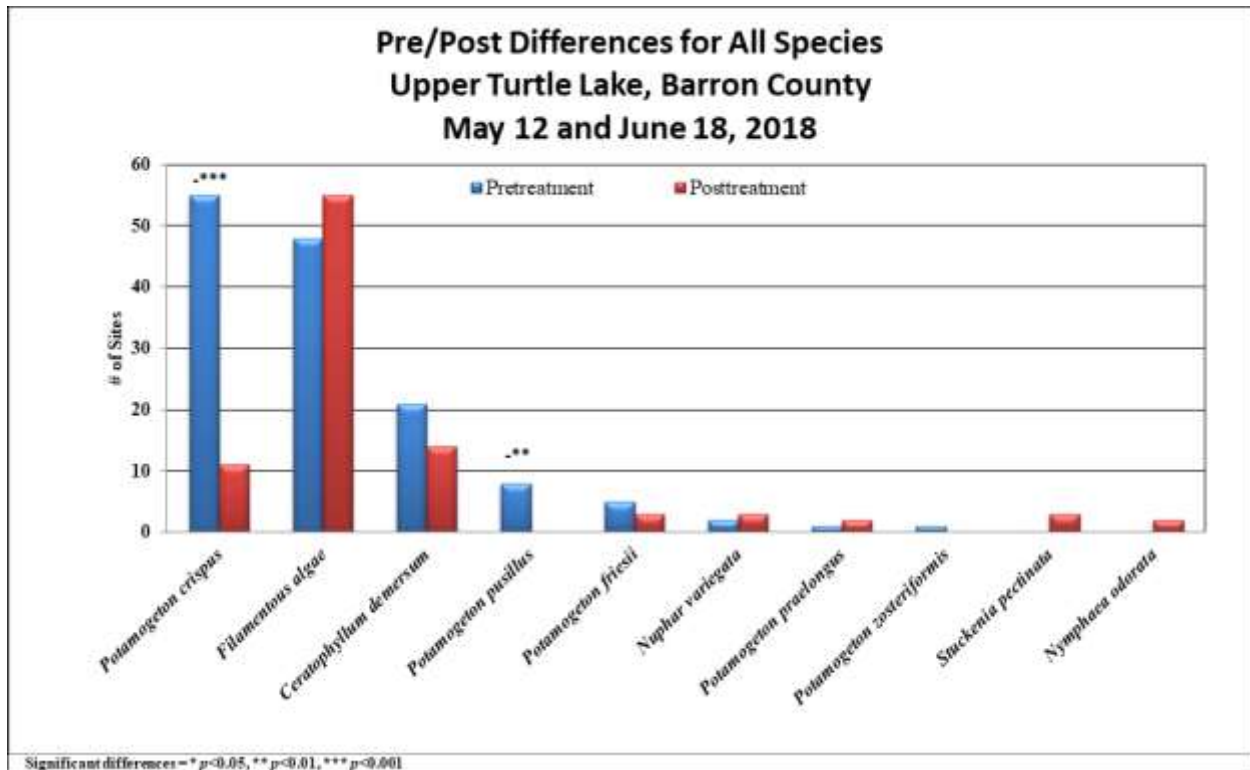
As for the presence of native aquatic plants, the littoral zone was essentially unchanged however, the frequency of occurrence at any point for any plant species dropped sharply from 92.4% pretreatment to 48.4% posttreatment. Total plant richness was unchanged with seven species found during each survey, so the elimination of CLP was often the elimination of the only plant that had been present pre-treatment. The Simpson’s Diversity Index increased from a moderate pre-treatment value of 0.59 to a moderately high post-treatment value of 0.76. The Floristic Quality Index (another measure of native plant community health) fell slightly from 15.5 pretreatment to 13.9 posttreatment (Table 4).

Figure 30: Pre/post-treatment aquatic plant changes

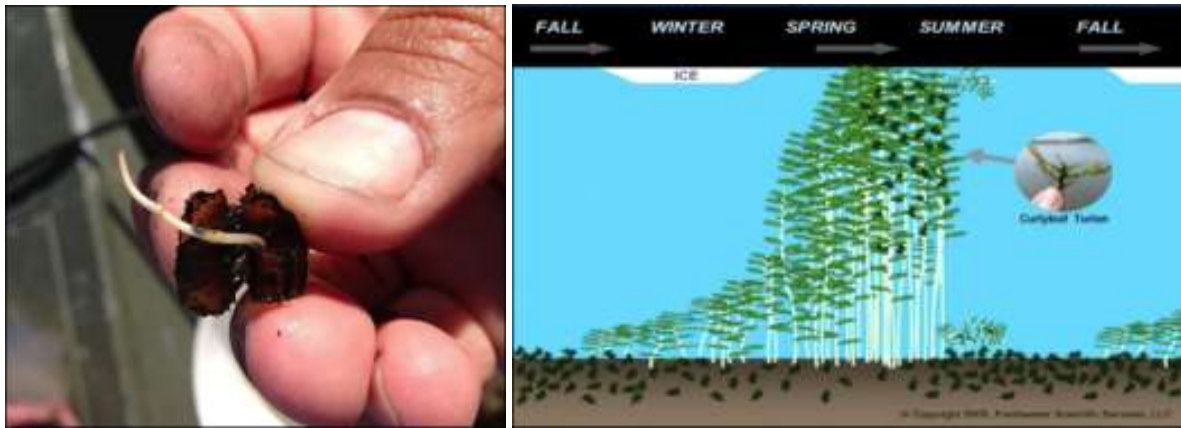
Figure 31: CLP sprouting from a previous year's turion (Berg, 2018); CLP life cycle (Johnson, 2006)

Research suggests approximately 50% of turions germinate in a growing season while the rest remain dormant until the following growing season when another 50% will germinate (Johnson, 2012). Depending on the level of turions at a given location and knowing that latent turions may be able to survive for over 5 years in the sediment, it may take several years of control to notice a reduction in the number of turions in the sediment.

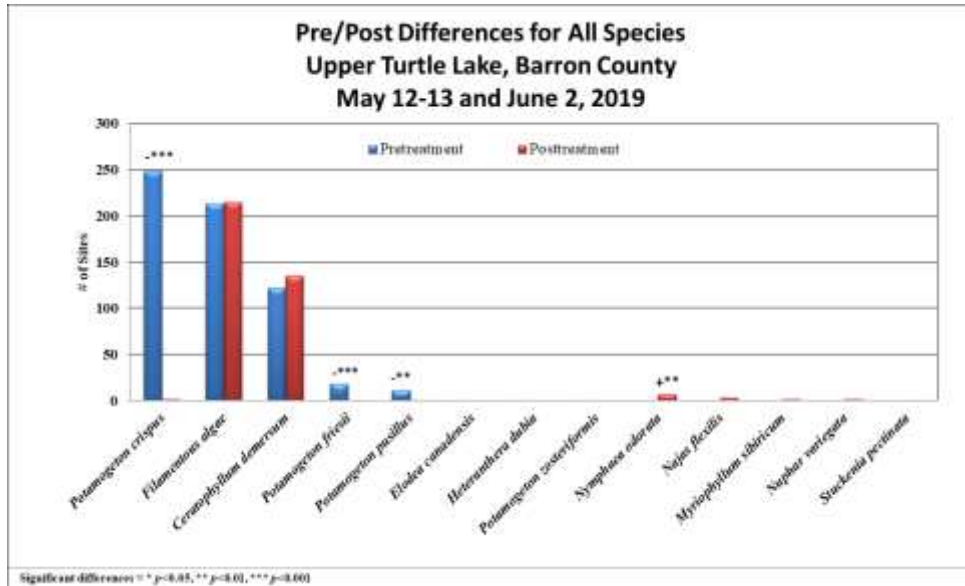
Several native aquatic plant species also suffered a significant decline. Coontail (*Ceratophyllum demersum*) was the most widely distributed native species in both the pre-treatment and post-treatment surveys. Fries' pondweed (*Potamogeton friesii*), the second most widely distributed species in the pre-treatment survey and a species known to be highly sensitive to endothall, appeared to have been eliminated from the treatment areas as none was found in the rake or seen inter-point anywhere post-treatment. Small pondweed, another species sensitive to endothall, also experienced a moderately significant decline in distribution. White water lily (*Nymphaea odorata*), a late-growing species, was the only plant that showed a moderately significant increase in distribution post-treatment (Figure 36).

Figure 36: 2019 Pre/post-treatment changes in aquatic plants

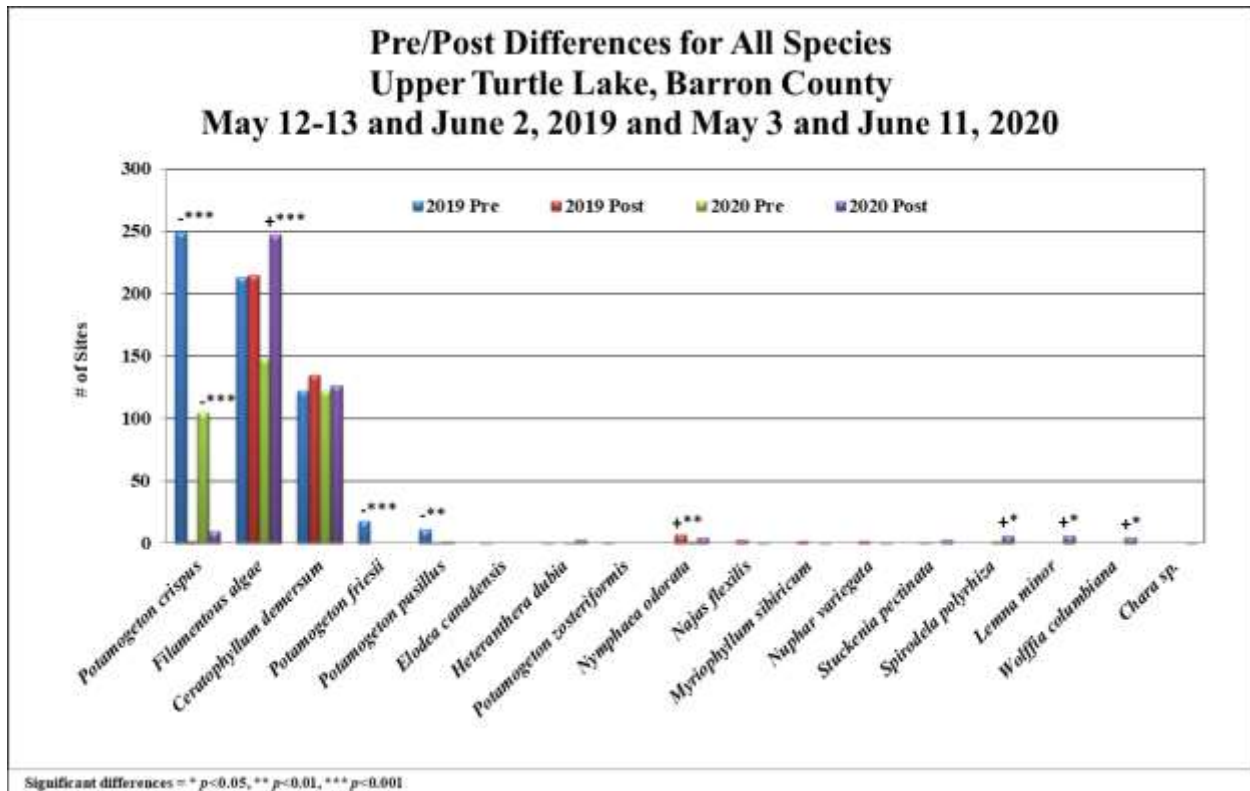
In 2019, White water lily, a late-growing species, was the only plant that showed a moderately significant increase in distribution post-treatment. The 2020 survey found filamentous algae experienced a highly significant increase in distribution and Small duckweed (*Lemna minor*), Large duckweed (*Spirodela polyrrhiza*), and Common watermeal (*Wolffia columbiana*) all had significant increases in distribution. Filamentous algae, the two duckweeds, and common watermeal are all species that generally do well in degraded water quality conditions and when other, larger, rooted plants disappear from the littoral zone. In addition to the three species just mentioned, Muskgrass (*Chara sp.*) also showed up for the first time, post-treatment. Water stargrass, Sago pondweed, Northern watermilfoil and Slender naiad were also present post-treatment in 2020 as they were in 2019 (Figure 39).

Figure 39: 2019-2020 Pre/post-treatment changes in aquatic plants

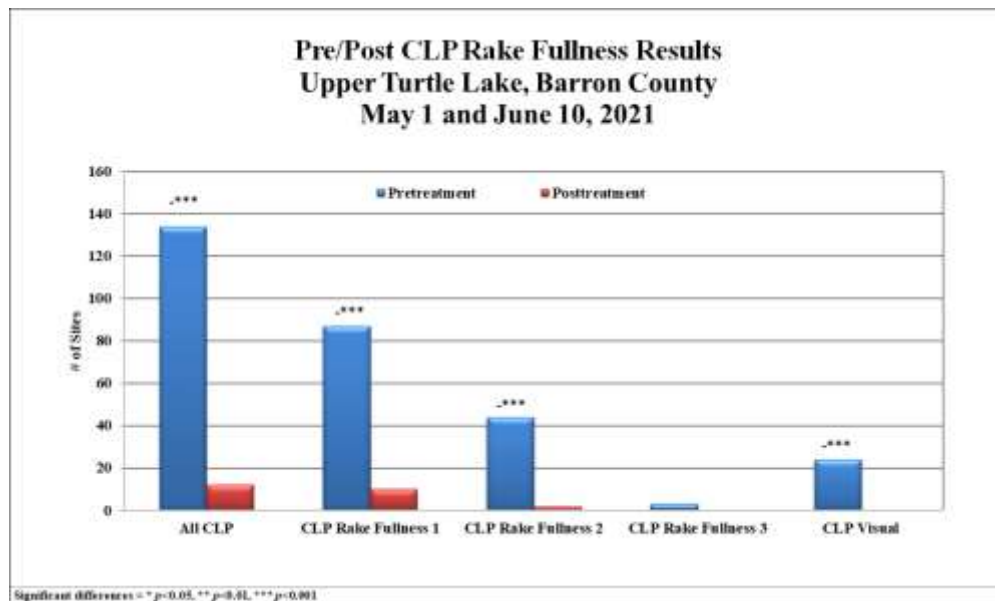
Figure 41: 2021 Pre/post-treatment changes in CLP rake fullness

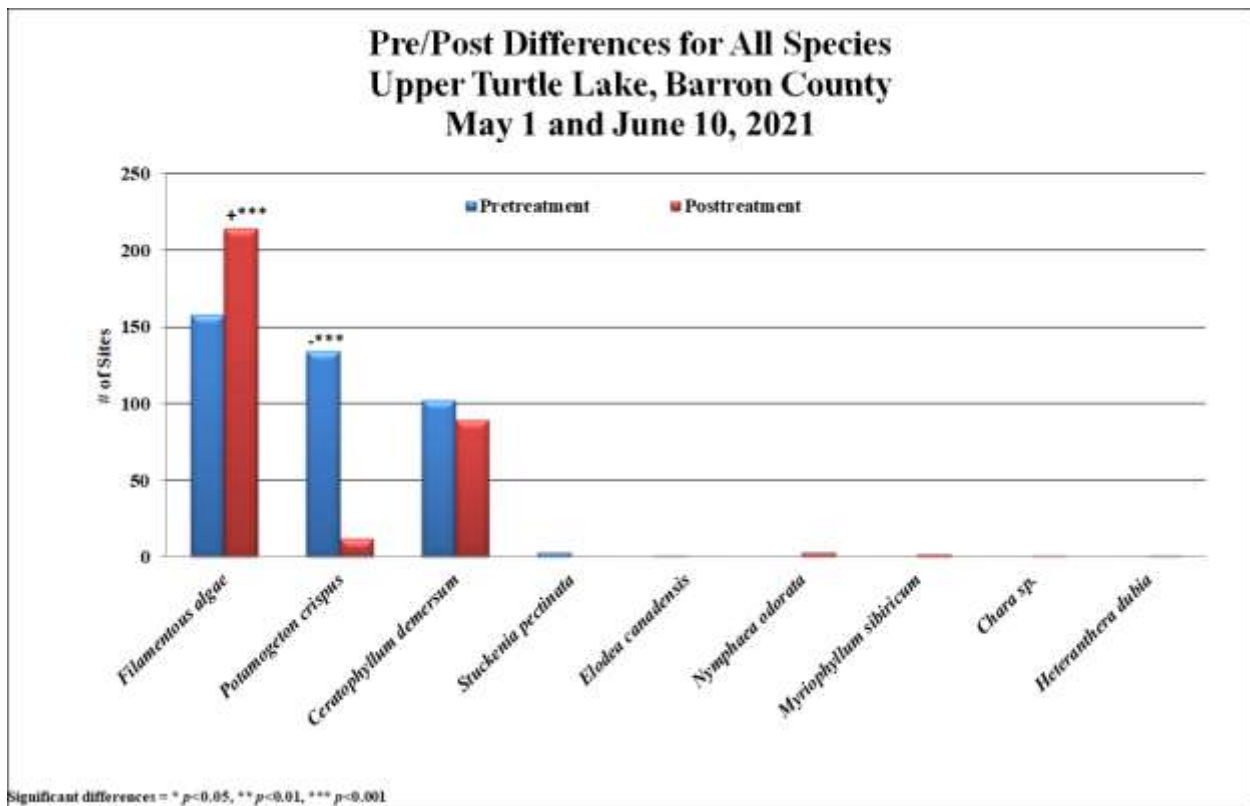
Figure 42: 2021 Pre/post-treatment changes in aquatic plants

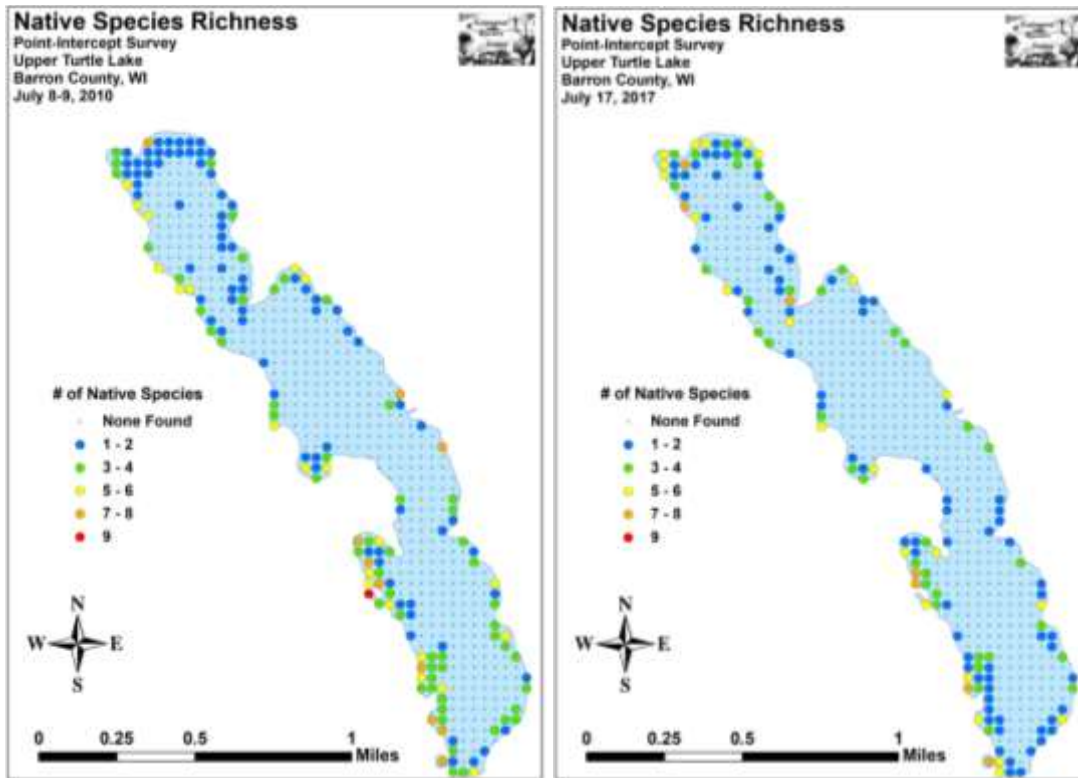
Figure 52: 2010 and 2017 Native Species Richness

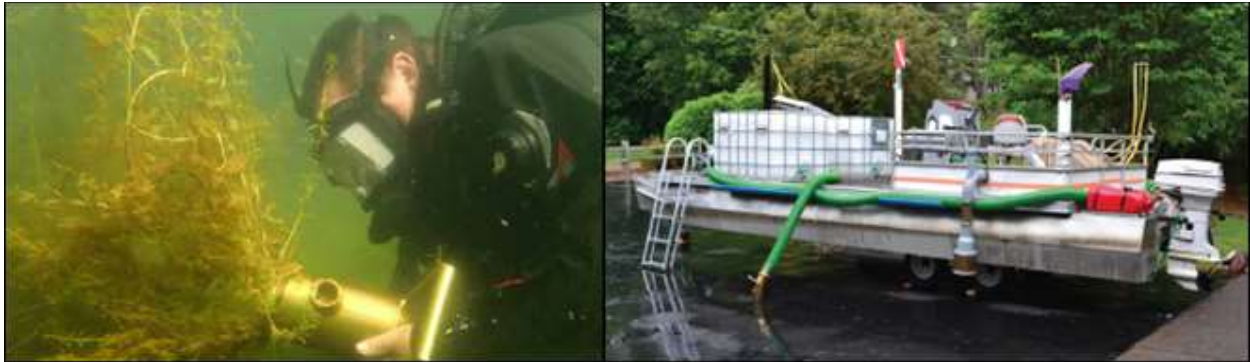
Figure 67: DASH – Feeding EWM into the underwater Suction Hose (Marinette Co.); and a sample DASH Pontoon Boat (Beaver Dam Lake Management District)

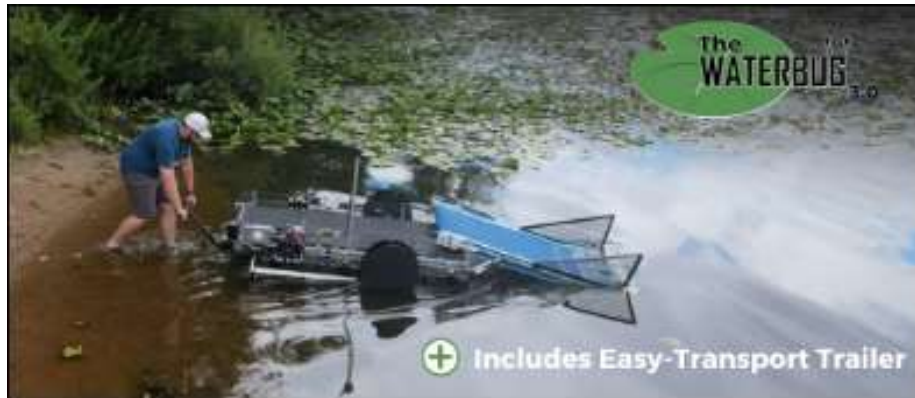
Figure 69: WaterBug remote-controlled aquatic plant harvester
(<https://lakeweedharvester.com/waterbug/>)

The WaterBug (Figure 69) is 5.4' wide by 11' 9" long but weighs only 370 lbs. and boasts a storage bunk capacity of 600 lbs. This makes it easy for one person to use as it fits on a compact trailer that can be pulled behind a 4-wheeler or garden tractor. It floats in as little as 4" of water and can cut and skim 34" wide, is

adjustable to 15-16" water depth by remote control (can be set manually to a depth of 24"), and features long-lasting batteries that can operate 5 hours on a single charge.

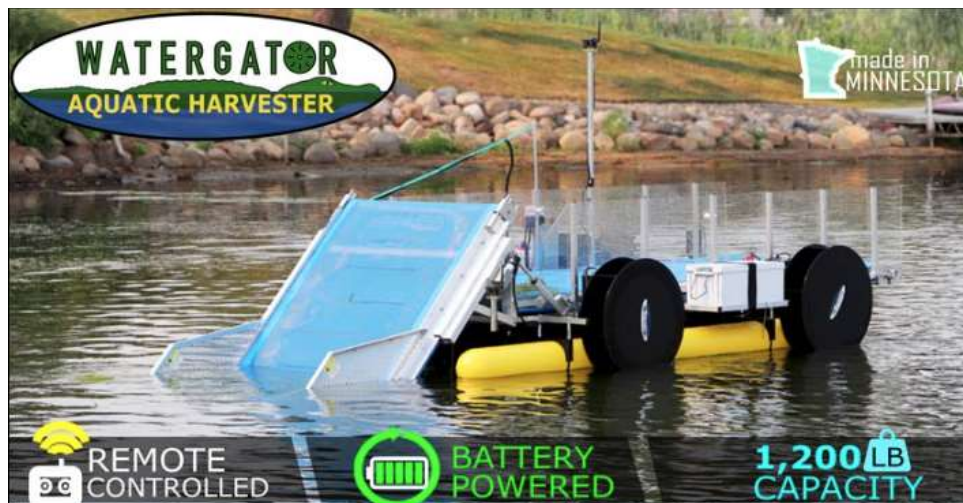
Figure 70: WaterGator remote-controlled aquatic plant harvester
(<https://lakeweedharvester.com/watergator/>)

The WaterGator (Figure 70) features the same technology as the WaterBug including a harvesting camera that shows the operator what the WaterGator sees on the remote viewing screen. The WaterGator cuts, skims, and collects aquatic vegetation. It is easy for any user to operate, and it is extremely versatile, with a cutting range reaching 3-1/2 feet deep, and a generous cutting and skimming width of 42 inches. It has a storage bunk capacity of 1,200 lbs. double that of the WaterBug. The WaterGator is battery powered, and provides the operator with 8-plus hours of run time on a single charge! The WaterGator is designed for larger ponds, lake shores, channels, and other medium size bodies of water.

The cost of a WaterBug is estimated at around \$17,000.00. The cost of a WaterGator is about double that at \$35,000.00. Table 11 compares the two different machines.
