Curly-leaf Pondweed (*Potamogeton crispus*) Bed Mapping Survey Upper Turtle Lake - WBIC: 2079800 Barron County, Wisconsin

2024 and 2025 Curly-leaf pondweed bed maps

Endangered Resource Services, LLC
Matthew S. Berg, Research Biologist
St. Croix Falls, Wisconsin
June 15, 2025

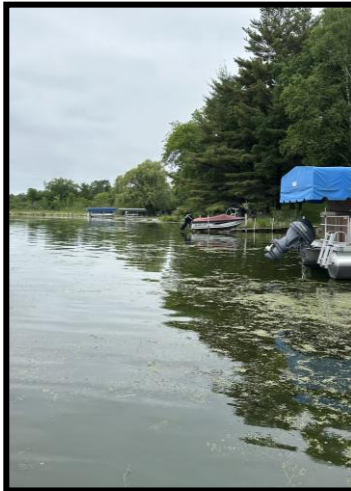
Canopied CLP in the "thumb bay" - 6/15/25

Bed 1 – The southwestern shoreline was ringed by native vegetation dominated by floating-leaf species. In areas beyond 3ft of water, Curly-leaf pondweed was again canopied into a nearly continuous bed. Bed 1A (the southwest corner) formed a narrow strip along the shoreline that, although dense, was likely too narrow to be more than a minor impairment. As in the past, the highest density areas occurred in Bed 1B in the northwest “thumb” bay where a few residents along the northeast shoreline of the bay likely experience at least moderate impairment (see front cover of the report). This bed represented the second largest area on the lake with continuous CLP.

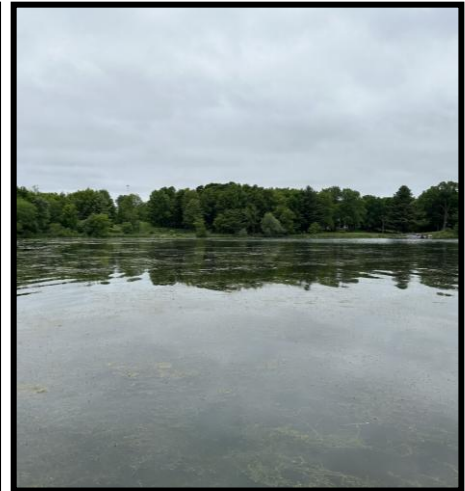
Dense canopied CLP bed in Bed 3 - 6/15/25

Beds 3 and 4 – Both of these beds on the west-central shoreline had dense canopied CLP that were likely causing at least moderate impairments for residents as evidenced by prop-trails throughout. As most of Bed 3 occurred along a nearly uninhabited shoreline, it is likely a lower management priority.

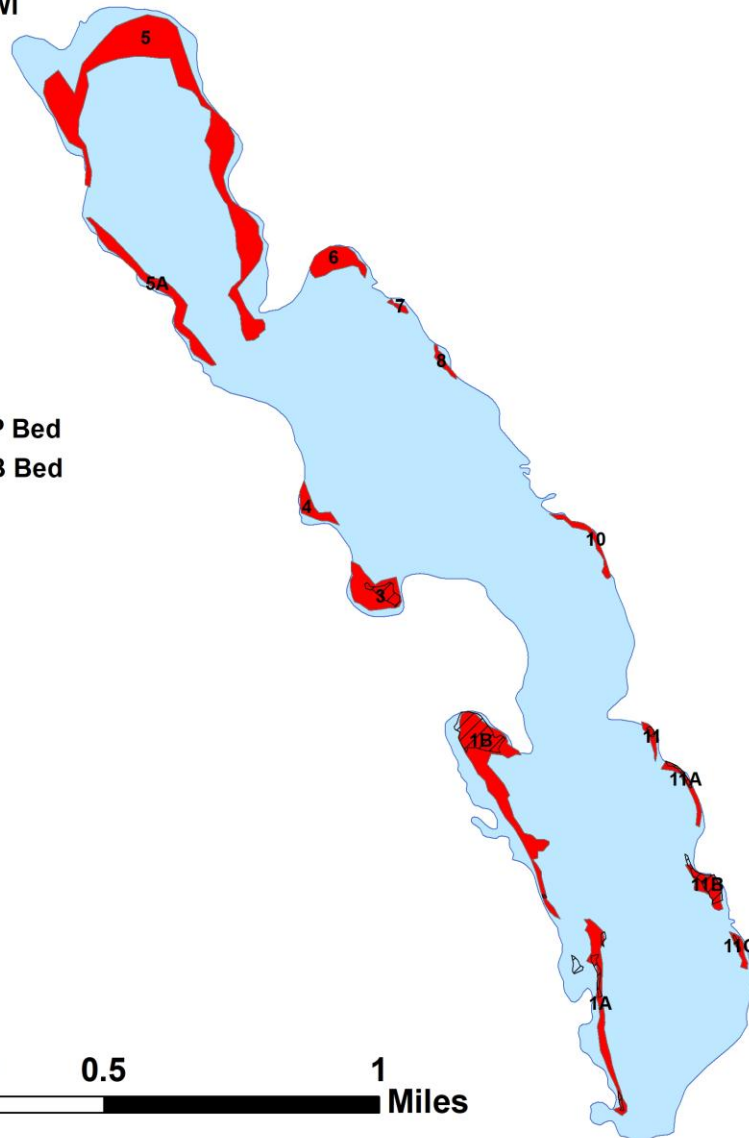
Exotic Species
CLP Bed Mapping Survey
Upper Turtle Lake
Barron County, WI
June 15, 2025

The 2025 survey documented 14 beds covering 45.88 acres (10.74% of the lake's surface area) (Figure 3) (Appendix I). Compared to 2024, there was an increase of 40.30 acres (+722.2%) (Table 1). Considering the late ice-on/early ice-off and prolonged cool spring coupled with a lack of management; these results were not surprising.

Bed 5: Dense canopied CLP was again present in the north bay, and this 20+ acre bed was the largest on the lake. Bed 5A on the southwest end of the bay was patchier and likely not more than a minor impairment. However, in the rest of the bay, most residents were likely experiencing at least moderate impairment, and we noted prop-trails throughout as boats were forced to cut through the mat.

Bed 6: This bed was likely at least a moderate impairment for residents in the bay. It was also likely worse earlier in the season as repeat boat traffic had ripped up large numbers of plants and created prop-trails throughout the bed.

Bed 11: This former giant bed was again fragmented into multiple small beds along the southeast shoreline. Beds 11, 11A , and 11C were very narrow strips and unlikely to be more than a minor impairment. Bed 11B was quite dense and less patchy than in the past. However, it was still likely too narrow to be more than a moderate impairment.
